BACK TO THE FUTURE Time, neglect and saltwater have all had their impact on the but after extensive reasing barbour but a

Time, neglect and saltwater have all had their impact on the repair swing bridge at Folkestone harbour, but after extensive repair swing bridge at Folkestone harbour, but after extensive repair successful to the second state and second state an swing bridge at Folkestone harbour, but after extensive repair works it is now ready for use again, albeit as a pedestrian walkway across the inner harbour

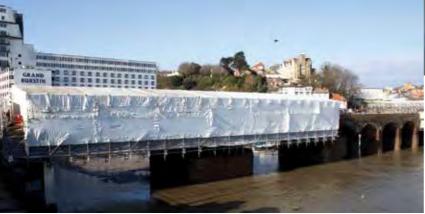
Repointing the brickwork and blastcleaning the steel took over 20,000 man hours

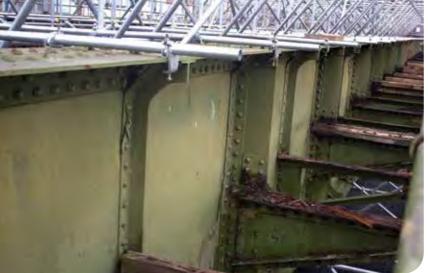
Above: Over 400 individual steel repairs were completed by a team of up to six welders by the chief engineer of the Sothern Railway, George Ellson, OBE MICE. It has three main longitudinal girders and sits on a brick base with stone quoins. The base is original to an earlier 1893 bridge on the site, which itself replaced an even older swing bridge. When operational, the bridge was swung open by means of an electric capstan on the wharf and a rope, with lifting and locking mechanisms hand operated.

Over 400 individual steel repairs were completed by a team of up to six welders from a local company, Cook Fabrications Ltd.
